**HUAWEI SoftCo
V100R003**

Troubleshooting Cases

Issue 01
Date 2011-07-30

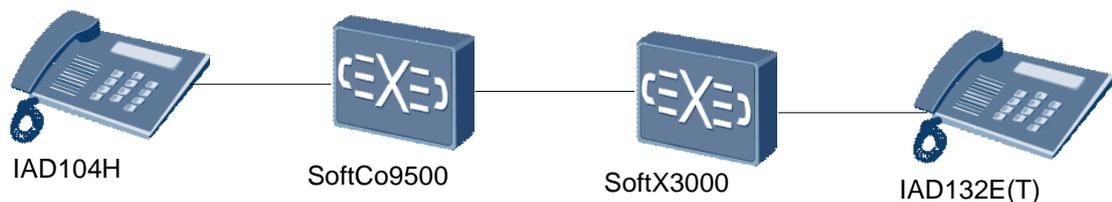
Figure 1-2 Connection between the Softco9500 and SoftX3000

Figure 1-2 shows the network.

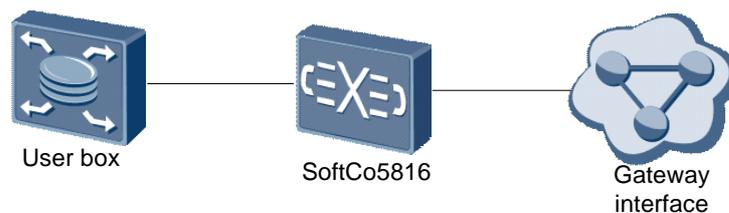
Figure 1-3 SoftCo5816 outgoing call network

Figure 1-3 shows the network.

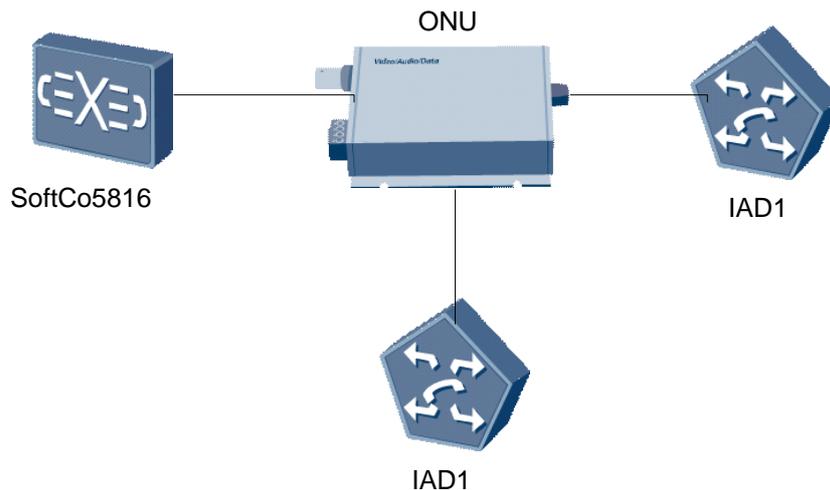
Figure 1-4 Connections between IADs and SoftCo using the ONU

Figure 1-4 shows the network.

A call between users on two IADs that are connected to the SoftCo using the same ONU can be connected successfully, but neither of the users can hear the voice after the call is connected. The call from the users to outer-office numbers, long numbers, or intra-office short number on other devices can be connected.

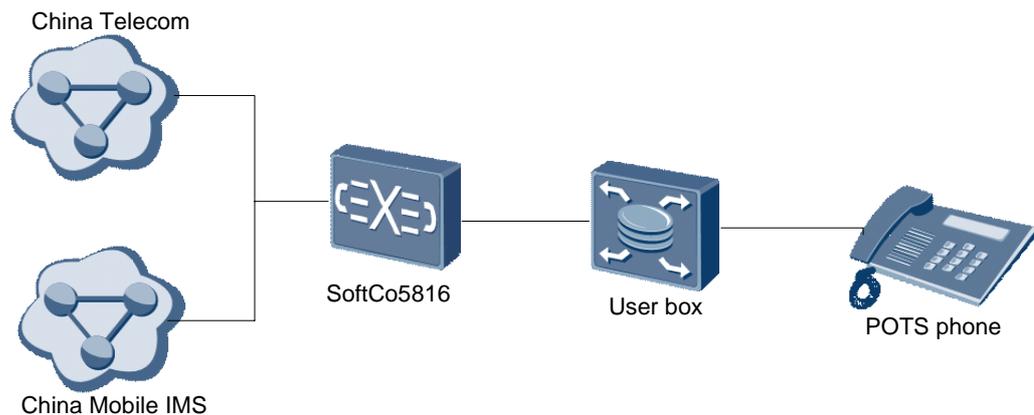
Figure 1-5 SoftCo5816 AT0 connection network

Figure 1-5 shows the network.

An outer-office user dials the access code of the VU switchboard, and hears the busy tone. There are three VUs on site, namely, two China Telecom AT0s, and one China Mobile IMS. The user hears the busy tone when dialing the access code of the two China Telecom VU switchboards, but successfully dials the China Mobile VU switchboard.

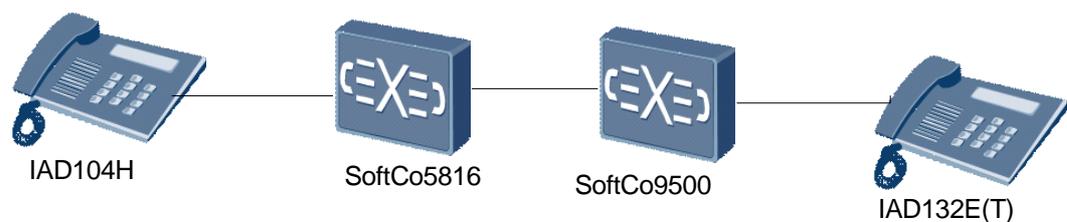
Figure 1-6 Network for receiving and sending faxes

Figure 1-6 shows the network.

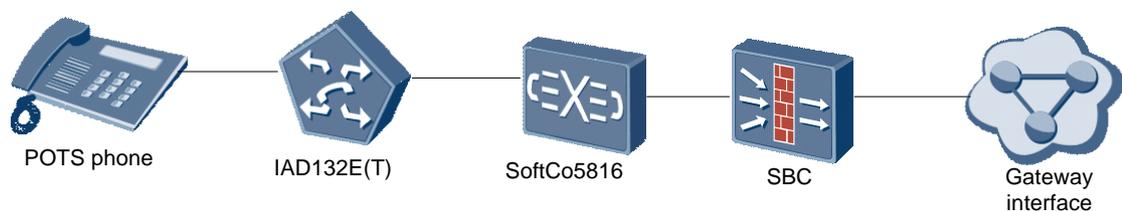
Figure 1-7 Network for canceling the CFU service

Figure 1-7 shows the network.

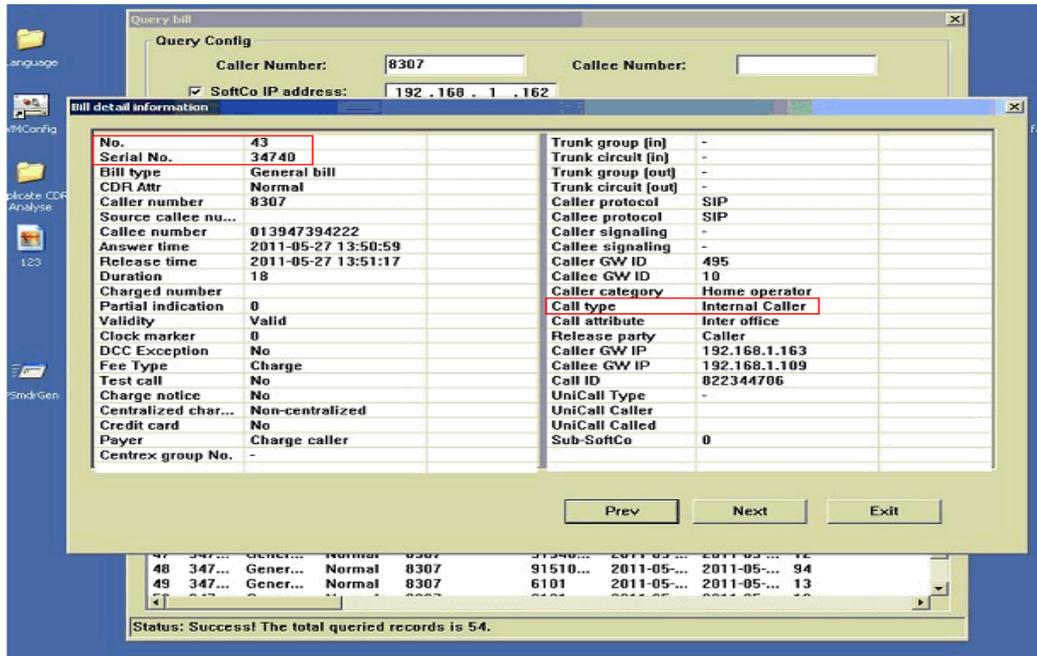
Figure 1-8 CDR 1

A hotel (office) uses the third-party charging software to perform charging based on the CDRs generated by the SoftCo. Some CDRs duplicate in the SoftCo, causing repeat charging. Figure 1-8 and Figure 1-9 show two duplicate CDRs.

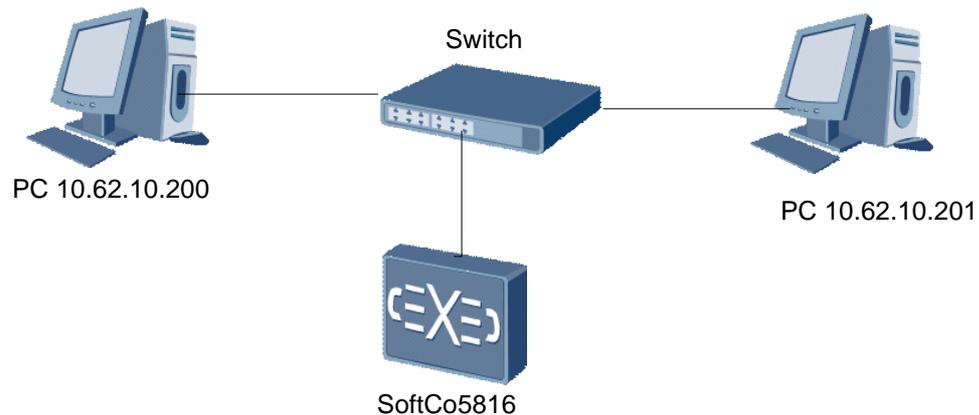
Figure 1-10 SoftCo Console system network

On two PCs connected to the SoftCo9500, the SoftCo Console Systems are installed. The SoftCo is in the V100R002C03 version. The IP addresses of the PCs are 10.62.10.200 and 10.62.10.201. [Figure 1-10](#) shows the network.

When a customer uses the Console system, the one-way voice blocking fault occurs. That is, PC2 can hear the voice from PC1 but PC1 cannot hear the voice from PC2 after a call is established.

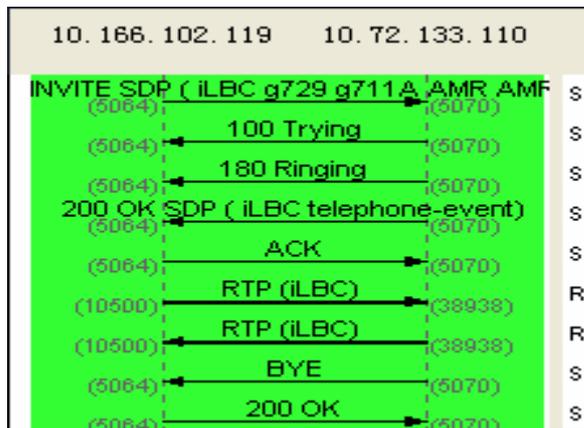
Figure 2-5 SIP signaling flowchart

The signaling flowchart is generated, as shown in Figure 2-5.

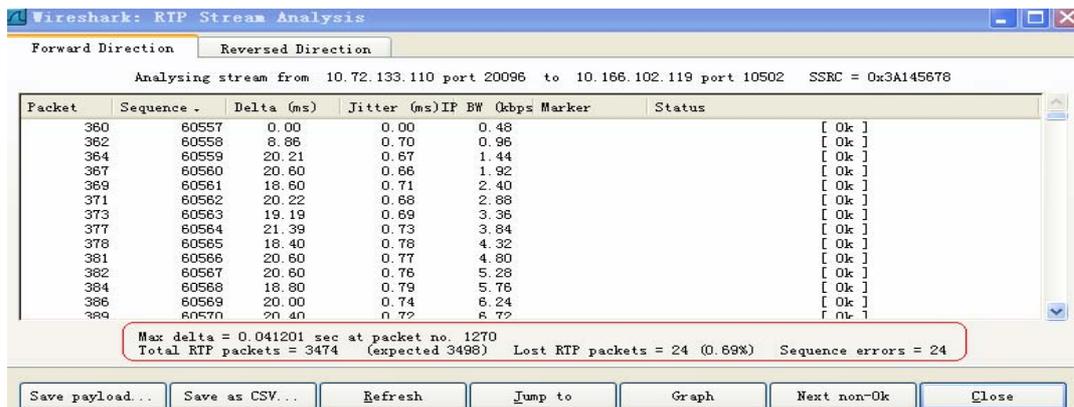
Figure 2-8 Analysis result

The RTP streams are simply analyzed and the analysis result contains the packet loss, jitter, and disorder information.

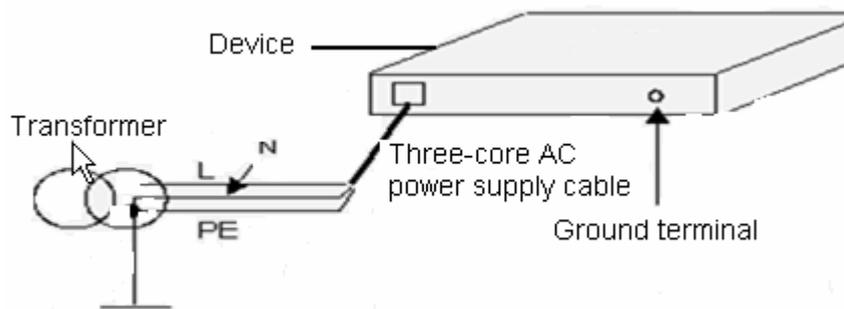
Figure 2-25 AC power supply ground

If a device uses 220 V AC power supply, the PE line of the AC power supply can be used as the ground cable, as shown in [Figure 2-25](#). Ensure that the PE line of the AC power supply is properly grounded inside the power distribution room or beside the AC voltage transformer. In addition, ensure that the PE terminal of the device is reliably connected to the PE line of the AC power supply. Use the three-core cable with PGND cable as the power cable for the device.

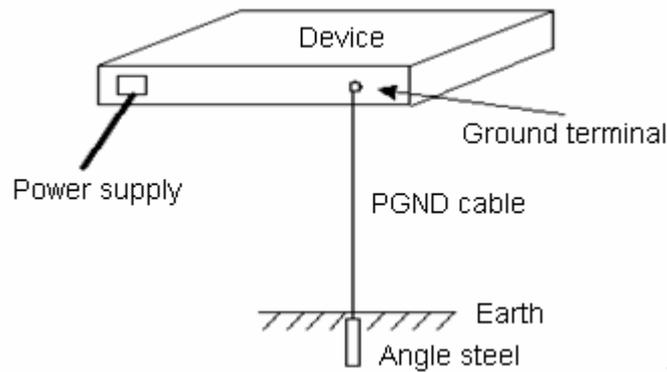
Figure 2-26 Ground without any ground bars

When no ground bar is installed in the equipment room, and the ground electrode can be buried in the ground electrode nearby, use an angle steel or steel pipe not shorter than 0.5 m. Bury the angle steel or steel pipe directly in the earth. The cross-sectional area of the angle steel should not be smaller than $L \times W \times H = 50 \times 50 \times 5 \text{ (mm}^2\text{)}$, and the steel pipe should not be thinner than 3.5 mm. The material used should be steel plated with zinc. Weld the yellow-green PGND cable of the device with the angle steel. Paint the surface of the welding point with anti-rustic paint. The cross-sectional area of the PGND cable must not be smaller than 4 mm^2 , and the PGND cable should be as short as possible. Do not wind the cable. See [Figure 2-26](#).

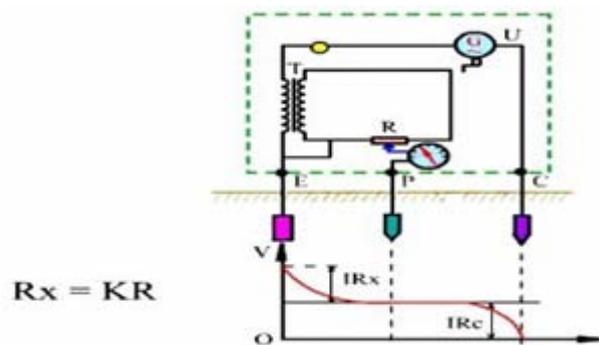
Figure 2-27 Ground impedance tester

Figure 2-27 shows the ground impedance tester.

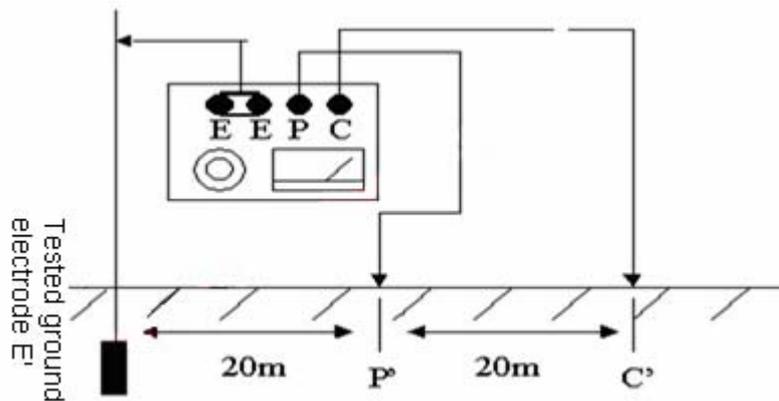
Figure 2-28 Connection diagram for testing impedance greater than or equal to 1 ohm

Figure 2-28 shows the connection diagram for testing impedance greater than or equal to 1 ohm.

- Step 1** Ensure that the connections between the tester, ground electrode, and probes are correct.
- Step 2** Place the tester horizontally and ensure that the pointer is on the central line.
- Step 3** Set the ratio scale to the maximum, rotate the electric generator handle slowly, and move the tester until the pointer is on the central line.
- Step 4** When the pointer becomes stable on the central line, rotate the electric generator quickly (more than 150 rounds per minute), and move the tester until the pointer is on the central line again.
- Step 5** If the reading is smaller than 1, change the ratio scale to a smaller one and perform the test again.
- Step 6** If the pointer shakes, change the handle rotating speed until the pointer becomes stable.

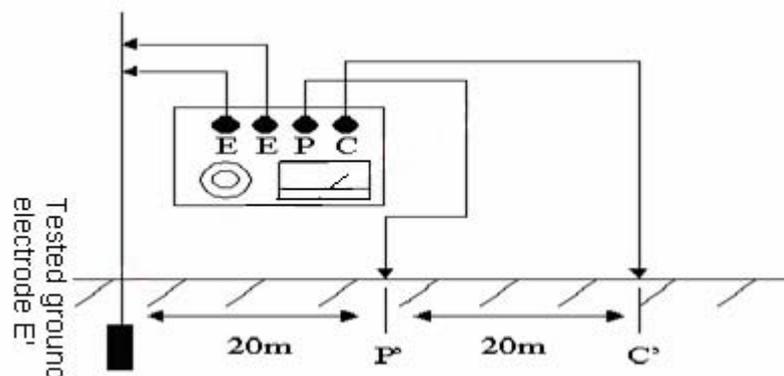
Figure 2-29 Connection diagram for testing impedance smaller than 1 ohm

Figure 2-29 shows the connection diagram for testing impedance smaller than 1 ohm (both conductors on points E are connected to the ground electrode).
