**IAD  
V300R001**

# **Troubleshooting Guide**

**Issue**        **01**  
**Date**        **2011-10-22**

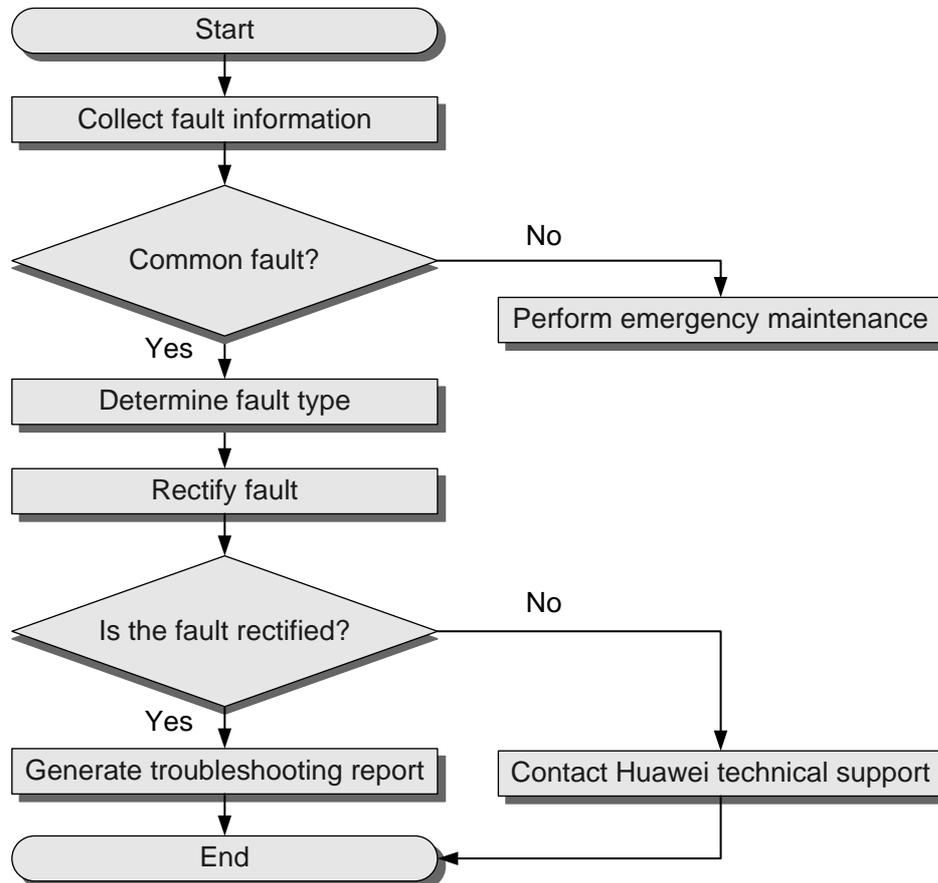
Figure 1-1 Troubleshooting process

Figure 1-1 shows the troubleshooting process.

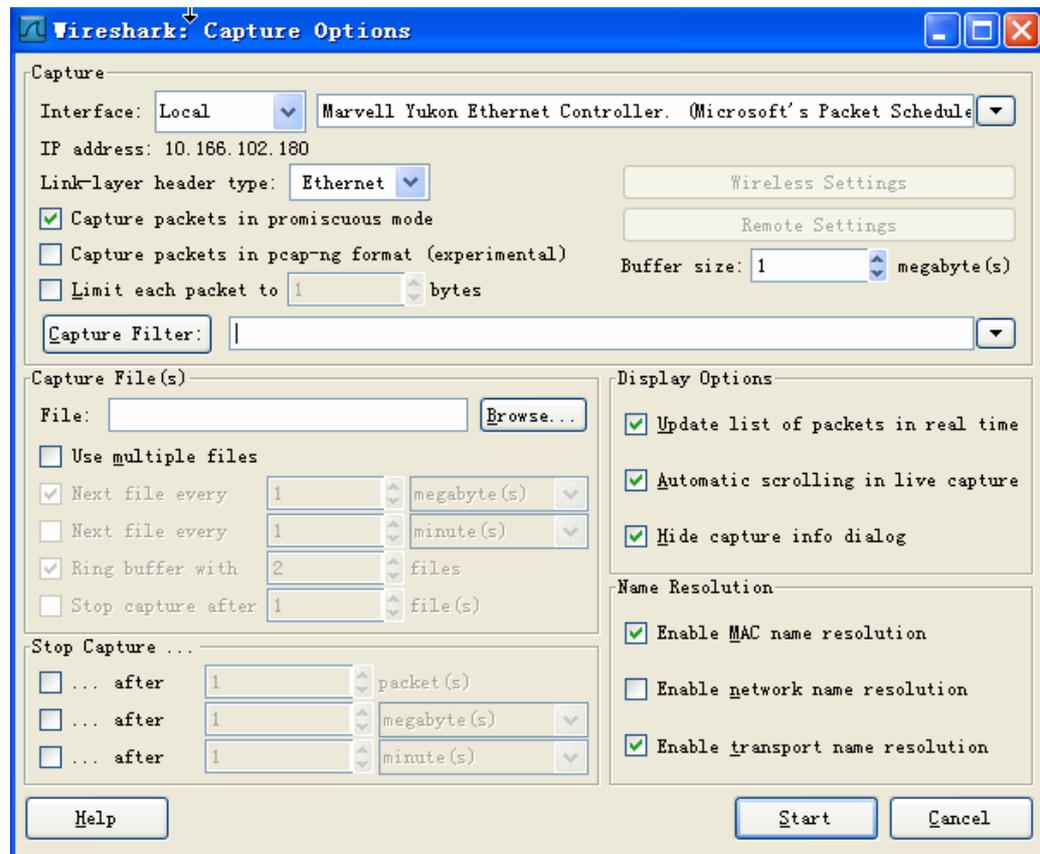
**Figure 3-1** Setting packet capturing options

**Step 1** Open the Wireshark, and click **Capture Options**. Click **Start** to start capturing packets, as shown in [Figure 3-1](#).

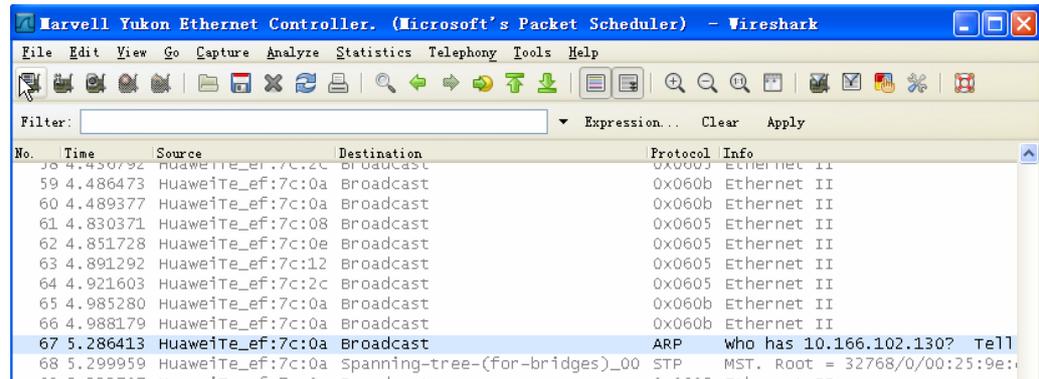
**Figure 3-2** Setting filter conditions

**Step 2** Set filter conditions to obtain required packets after packets are captured, as shown in [Figure 3-2](#).

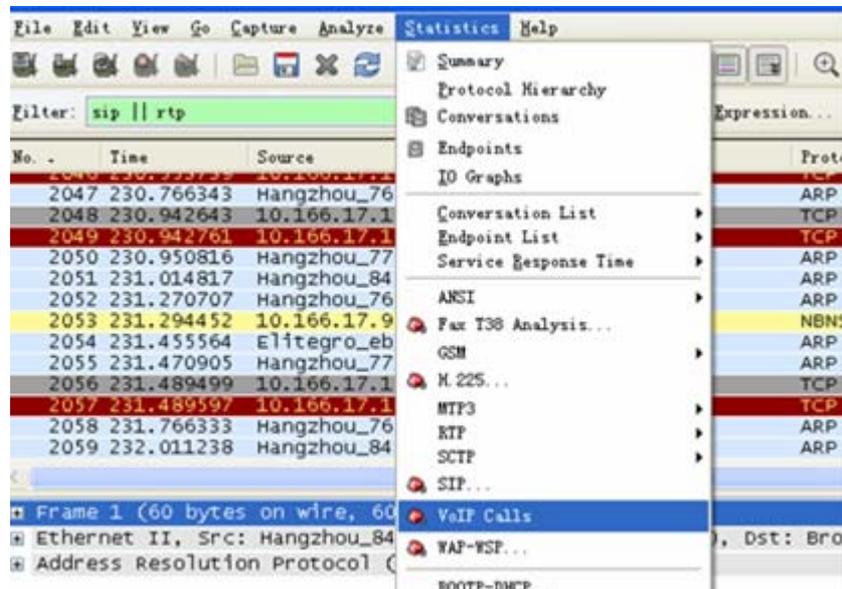
**Figure 3-3** Analyzing packets

**Step 4** Choose **Statistics > VoIP Calls**, as shown in [Figure 3-3](#).

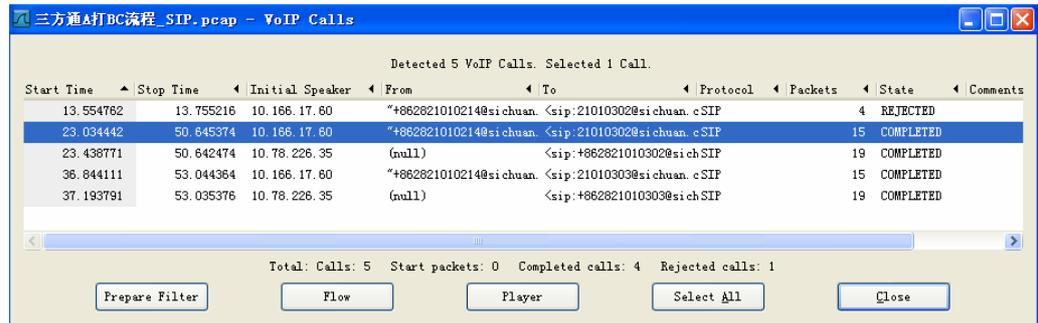
**Figure 3-4** Selecting a call

**Step 5** Select a call based on the calling number and called number, as shown in [Figure 3-4](#).

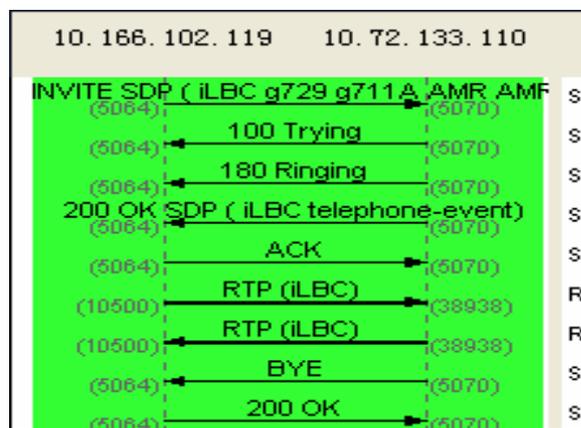
**Figure 3-5** SIP signaling flow

**Step 6** Click Flow. The SIP signaling flow for the call is displayed, as shown in Figure 3-5.

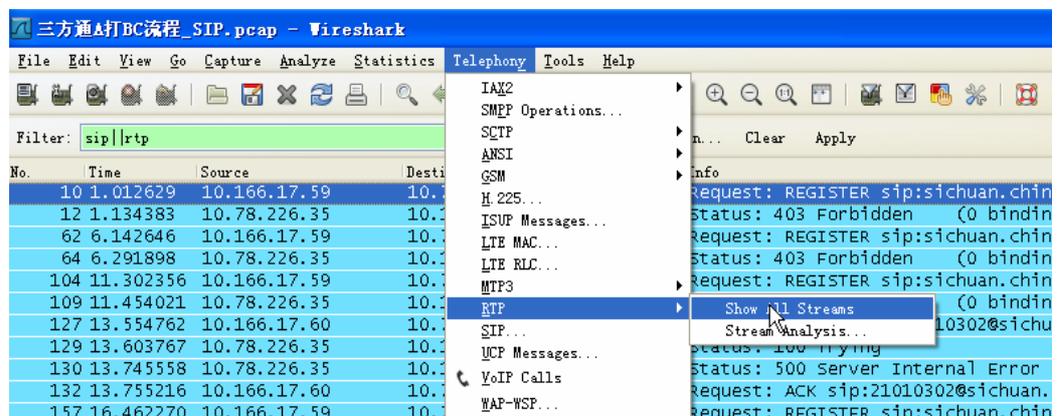
**Figure 3-6** Analyzing RTP streams

**Step 7** Choose **Telephony > RTP > Show All Streams** to analyze RTP streams, as shown in Figure 3-6.

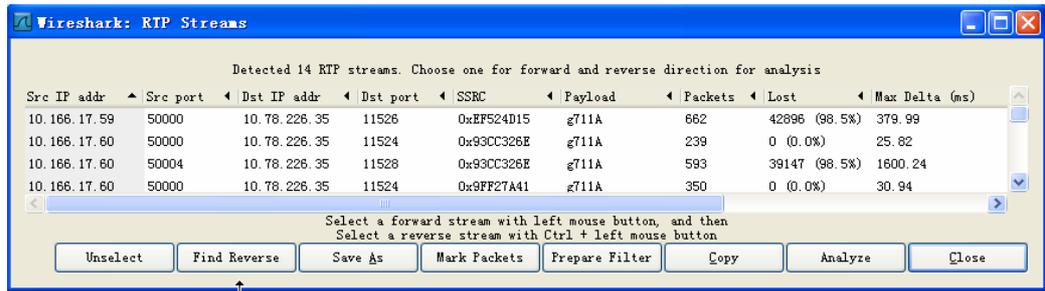
**Figure 3-7** Selecting an RTP stream

**Step 8** Select the data to analyze and click **Analyze**.

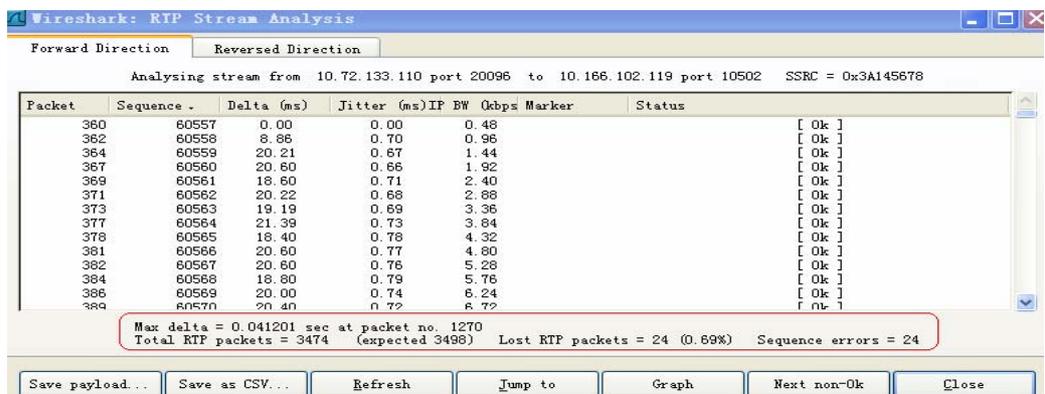
**Figure 3-8** Analyzing the result

By performing the preceding steps, you can analyze the RTP stream and evaluate the quality of the bearer network based on the packet loss, jitter, and disorder data.
