**SoftCo VoIP Integrated Exchange  
V100R002C04SPC600  
Troubleshooting**

**Issue**        05  
**Date**        2012-1-17

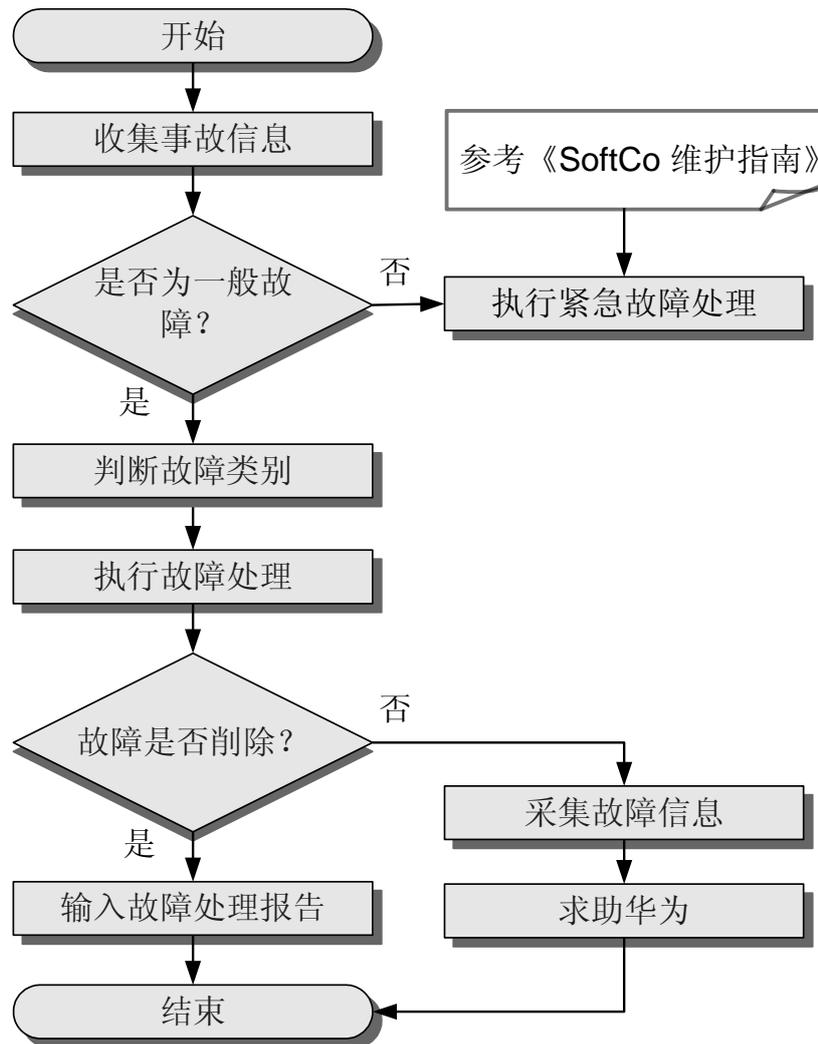
Figure 1-1 Troubleshooting process

[Figure 1-1](#) shows the overall troubleshooting process.

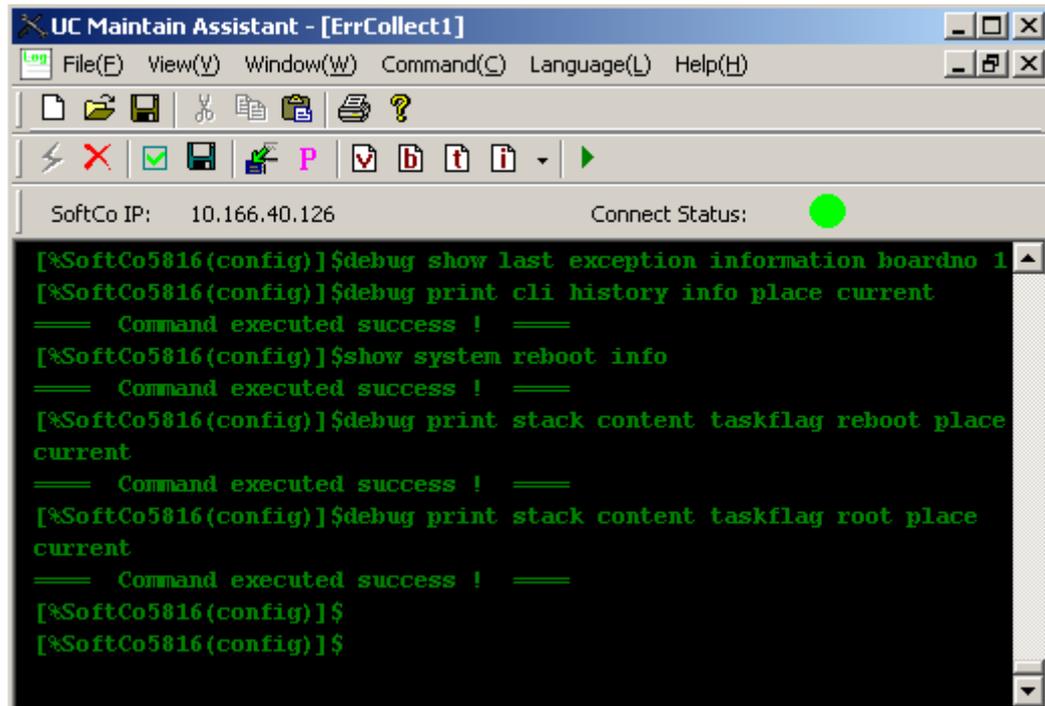
**Figure 2-3** Data configuration information

, the related configure data will displayed down the main window, as shown in [Figure 2-3](#).

You view whether the data is right, such as the board status, trunk link, and so on.

The screenshot shows a window titled "UC Maintain Assistant - [ErrCollect1]". The window has a menu bar with "File(F)", "View(V)", "Window(W)", "Command(C)", "Language(L)", and "Help(H)". Below the menu bar is a toolbar with various icons. The main area of the window displays a terminal window with the following text:

```
SoftCo IP: 10.166.40.126          Connect Status: ●  
[%SoftCo5816(config)]$debug show last exception information boardno 1  
[%SoftCo5816(config)]$debug print cli history info place current  
==== Command executed success ! ====  
[%SoftCo5816(config)]$show system reboot info  
==== Command executed success ! ====  
[%SoftCo5816(config)]$debug print stack content taskflag reboot place  
current  
==== Command executed success ! ====  
[%SoftCo5816(config)]$debug print stack content taskflag root place  
current  
==== Command executed success ! ====  
[%SoftCo5816(config)]$  
[%SoftCo5816(config)]$
```

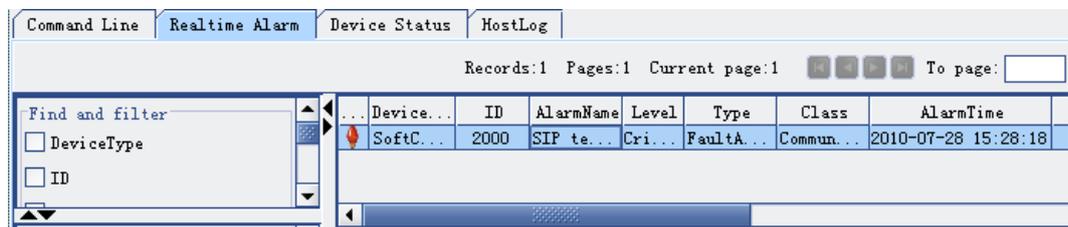
**Figure 2-4** Realtime Alarm tab page

- Use the OMU to view alarm information.
1. On the OMU main page, click the **Realtime Alarm** tab to view alarm information, as shown in [Figure 2-4](#).

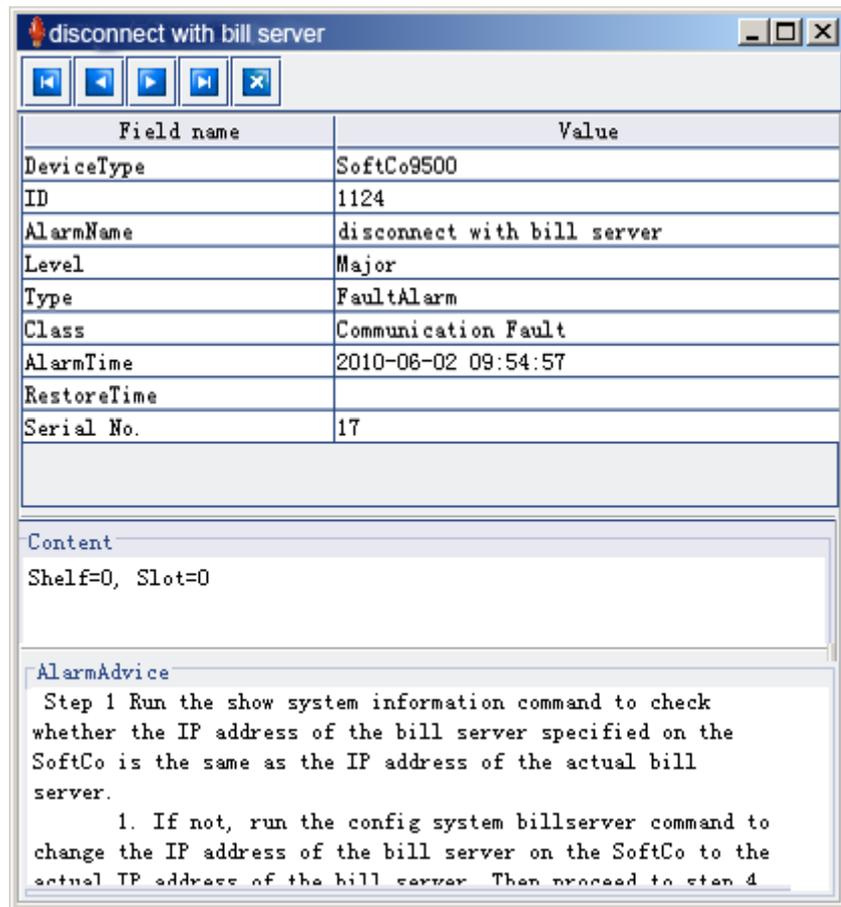
**Figure 2-5** Detailed alarm information

2. In the alarm browse area, double-click a required alarm. The detailed alarm information is displayed, as shown in [Figure 2-5](#).

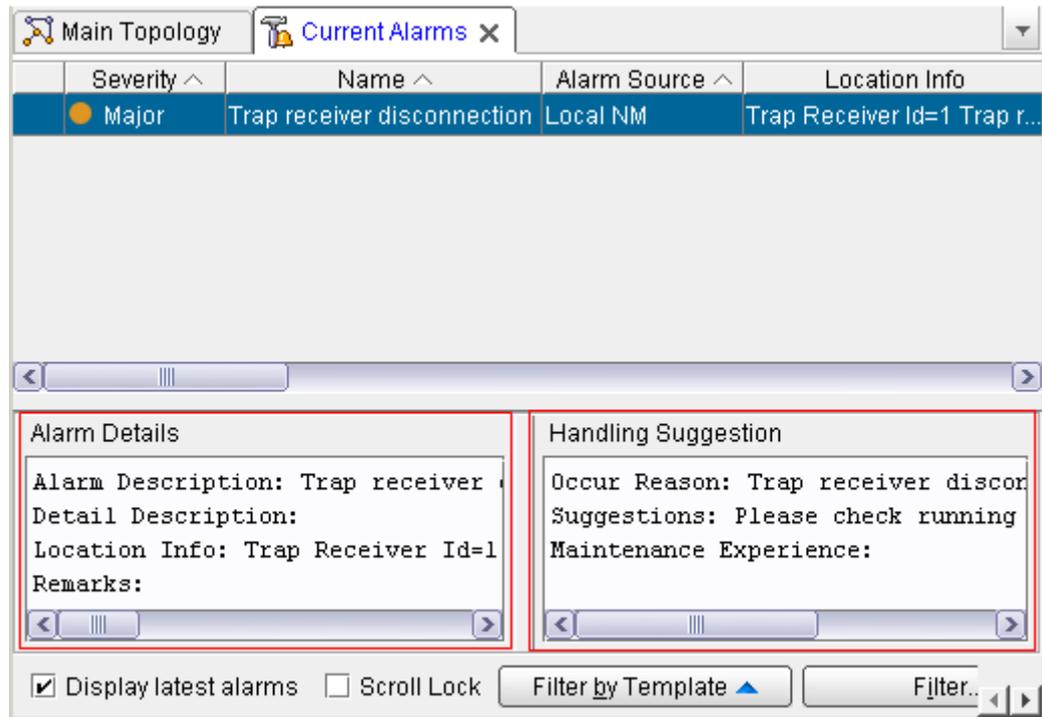
**Figure 2-6** Current alarm information

The alarm details along with the suggestions are displayed, as shown in [Figure 2-6](#).

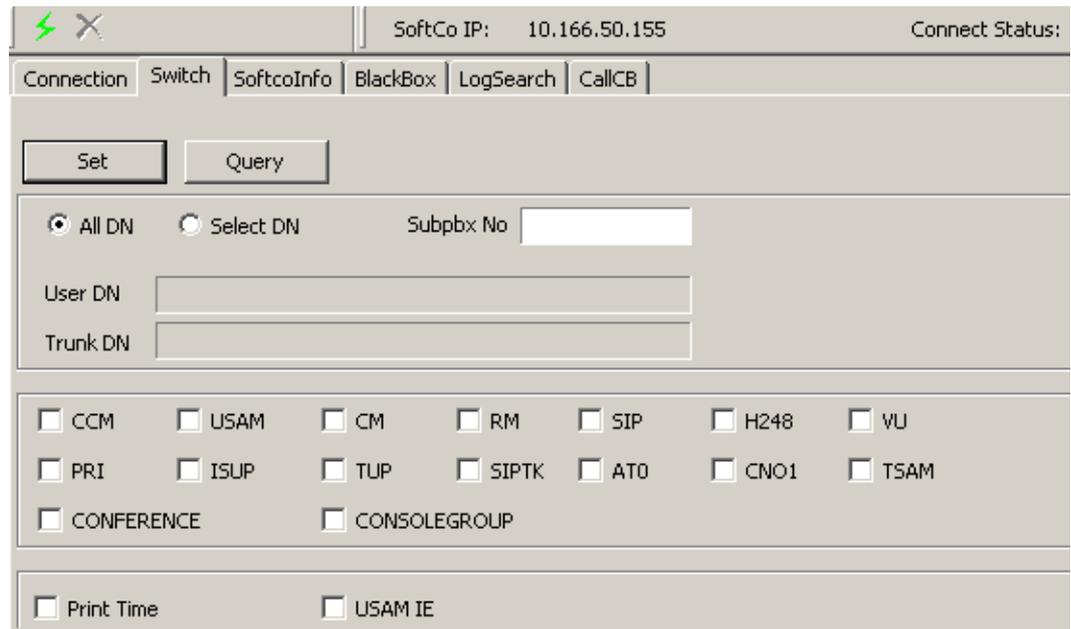
**Figure 2-7** Switch tab page

1. Click the **Switch** tab. Select required log modules, and click **Set** to enable the log module functions, as shown in [Figure 2-7](#).

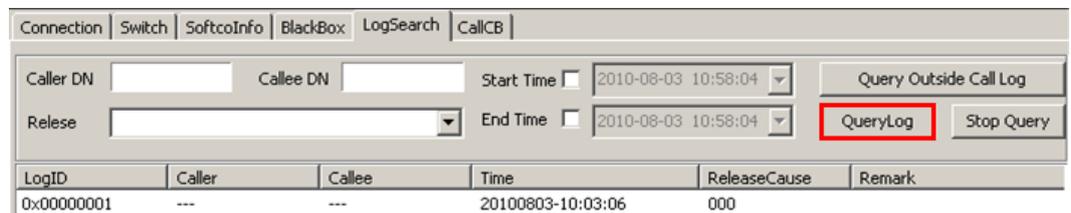
**Figure 2-8** LogSearch tab page

2. Click the **LogSearch** tab. Set parameters such as the calling number and called number, and click **QueryLog**, as shown in [Figure 2-8](#).

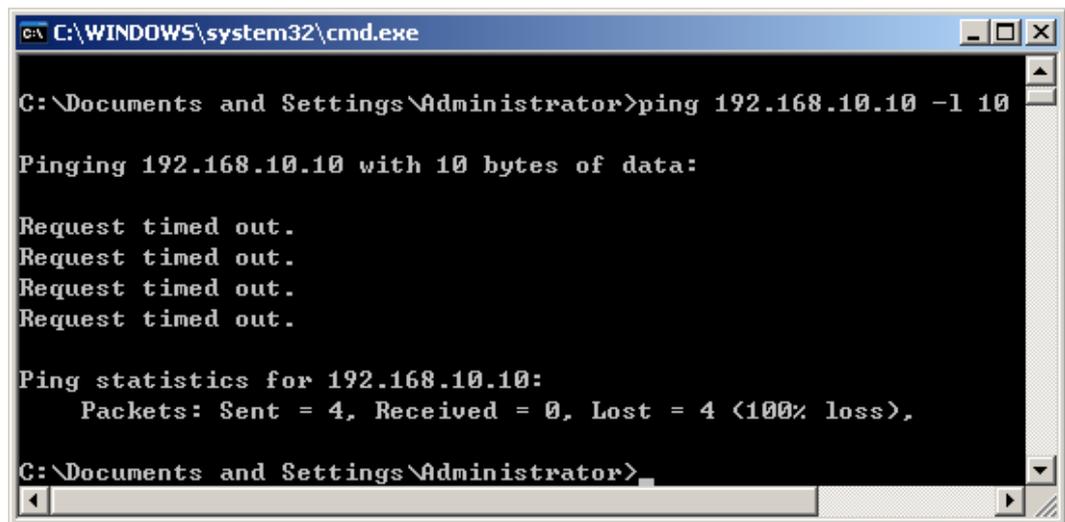
**Figure 2-11** Cmd

- Run the **ping<a.b.c.d> -l<count>** command in the command line interface (CLI) of a personal computer to check the network status.
  1. Choose **Start > Run**, and then enter the **cmd** command in the **Run** dialog box.
  2. Click **OK** to display the CLI, as shown in [Figure 2-11](#).

3. Enter **ping** command to check the network status. The abnormal network status is shown in [Figure 2-11](#)

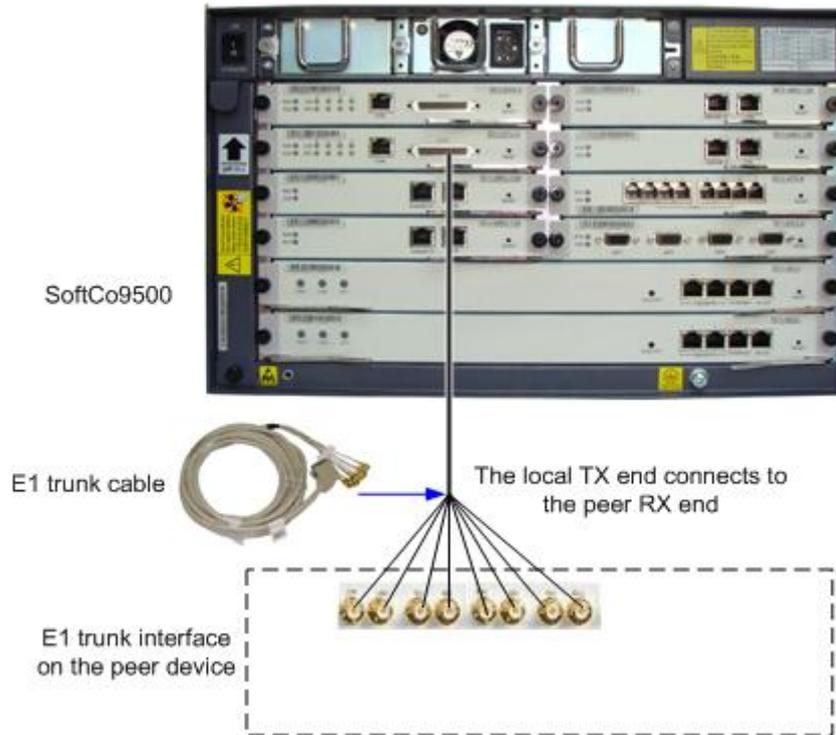
**Figure 4-1** Connecting the SoftCo9500 to the peer device with the E1 cable

The SoftCo9500 is connected to the peer device with the E1 cable, as shown in [Figure 4-1](#).

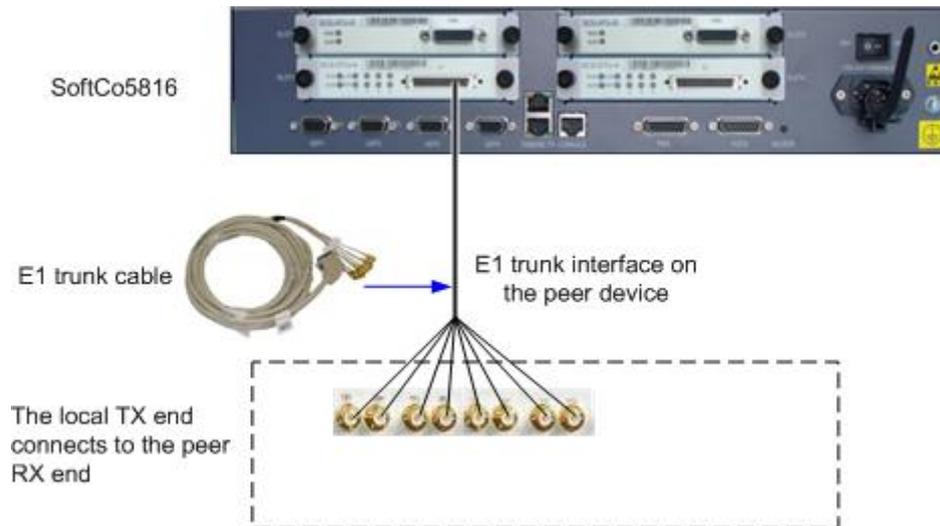
**Figure 4-2** Connecting the SoftCo5816 to the peer device with the E1 cable

The SoftCo5816 is connected to the peer device with the E1 cable, as shown in [Figure 4-2](#).

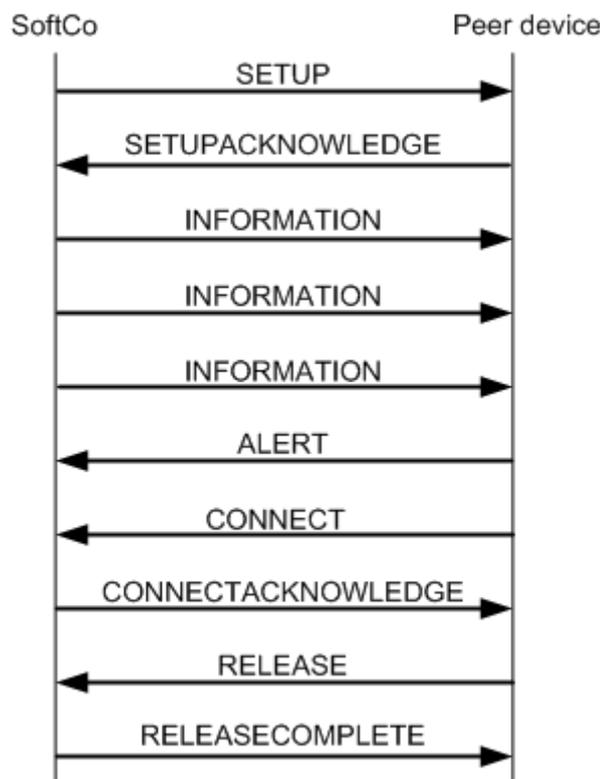
**Figure 4-3** Normal signaling process for a call initiated by a POTS user

- A POTS user in SoftCo calls a user in peer device, as shown in [Figure 4-3](#).

The signaling process is described as follows:

1. When an intra-office user calls an peer user, SoftCo sends a SETUP message to peer device, requesting to set up a call.
2. Peer device sends a SETUPACKNOWLEDGE message, indicating that the call is being set up.

3. SoftCo sends an INFORMATION message with the information required for setting up the call(For example, caller number and callee number).
  4. Peer device sends an ALERT message, indicating that the phone of the peer user rings.
  5. Peer device sends a CONNECT message, indicating that the peer user picks up the phone.
  6. SoftCo sends a CONNECTACKNOWLEDGE message, indicating that the office user A has learned that the peer user has picked up the phone.
  7. The intra-office user starts to talk with the peer user.
  8. Peer device sends a RELEASE message, indicating that the peer user hangs up.
  9. SoftCo sends a RELEASECOMPLETE message, indicating that the intra-office user hangs up. SoftCo and peer device release channel resources.
- A SIP user in SoftCo calls a user in peer device, as shown in [Figure 4-4](#).

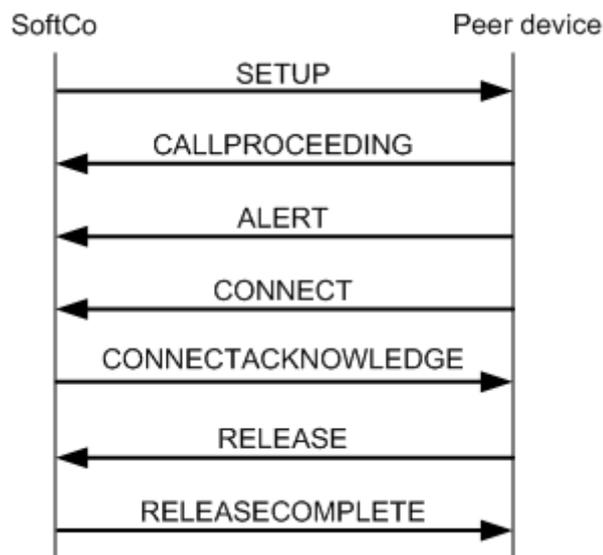
**Figure 4-4** Normal signaling process for a call initiated by a SIP user

The signaling process is described as follows:

1. When an intra-office user calls an peer user, SoftCo sends a SETUP message, requesting to set up a call.
2. Peer device returns a CALLPROCEEDING message, indicating that the call is being set up.
3. Peer device sends an ALERT message, indicating that the phone of the peer user rings.
4. Peer device sends a CONNECT message, indicating that the peer user picks up the phone.
5. SoftCo sends a CONNECTACKNOWLEDGE message, indicating that the intra-office has learned that the peer user has picked up the phone.
6. The intra-office user starts to talk with the peer user.
7. Peer device sends a RELEASE message, indicating that the peer user hangs up.
8. SoftCo sends a RELEASECOMPLETE message, indicating that the intra-office user hangs up. SoftCo and peer device release channel resources.

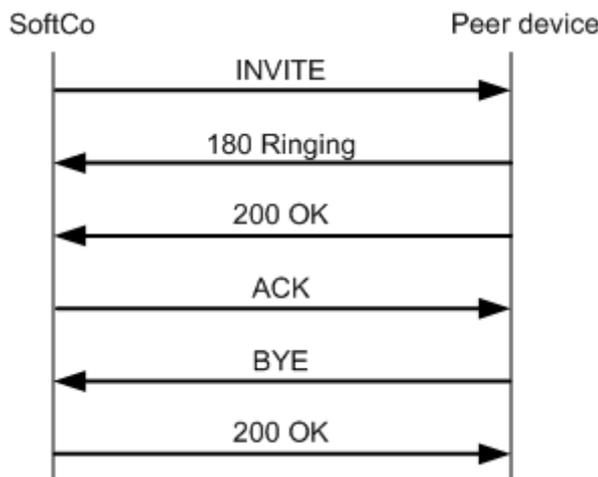
Figure 4-5 Normal signaling process

Figure 4-5 shows the normal signaling process.

The normal signaling process is as follows:

1. When an intra-office user attempts to call an peer user, SoftCo sends an INVITE message to set up a call.
2. Peer device sends a 180 Ringing message indicating that the peer user's phone is ringing.
3. Peer device sends a 200 OK message indicating that the peer user has picked up the phone.
4. SoftCo sends an ACK message indicating that the intra-office user is talking with the peer user.
5. Peer device sends a BYE message indicating that the peer user has hung up.
6. SoftCo sends a 200 OK message indicating that the intra-office user has been informed that the office user B has hung up. The intra-office user then hangs up.

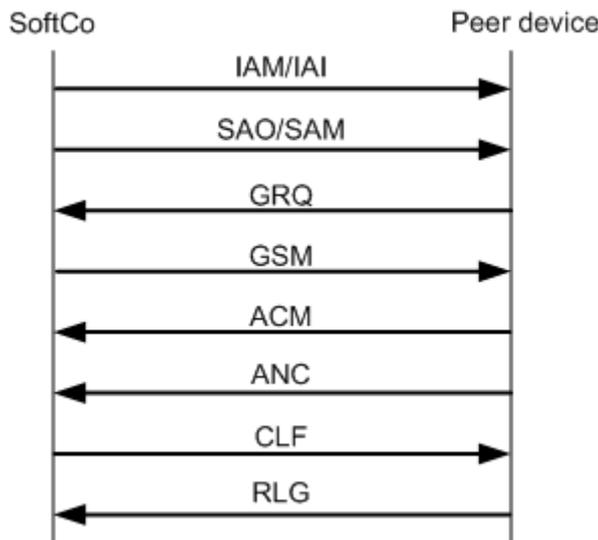
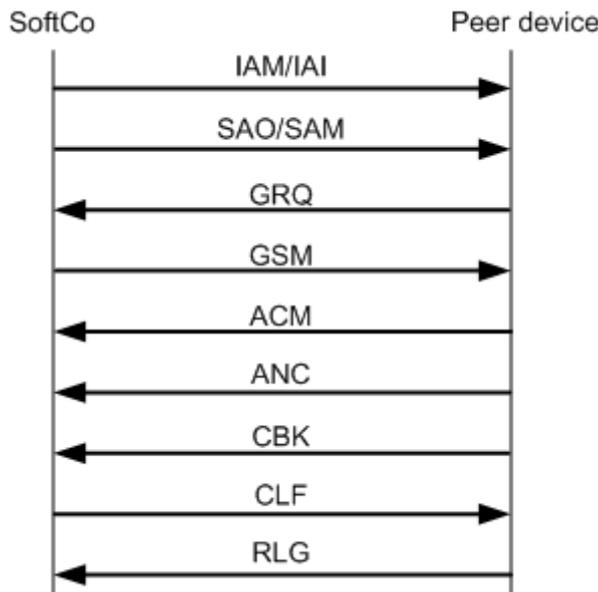
- [Figure 4-6](#) and [Figure 4-7](#) show the normal signaling process.

**Figure 4-6** Normal TUP signaling process (intra-office user first hangs up)

**Figure 4-7** Normal TUP signaling process (peer user first hangs up)

The normal signaling process is as follows:

1. When intra-office user calls peer user, SoftCo device sends an IAM message or an IAI message containing the information about initial address.
2. SoftCo device sends an SAO message or an SAM message containing the information about peer user address.
3. If other information is required for connecting the call, peer device sends a GRQ message requesting other information.
4. After receiving the GRQ message, SoftCo device encapsulates the required information into a GSM message. Then the GSM message is sent. In this case, all the information required for establishing the call is collected.

5. Peer device locates the user according to the information and sends an ACM message. Intra-office user plays the RBT and peer user phone rings.
  6. After peer user picks up the phone, SoftCo device sends an ANC message indicating that peer user has picked up the phone.
  7. Intra-office user starts to talk with peer user.
  8. The mode of sending messages according to the hangup sequence.
    - If intra-office user first hangs up, SoftCo device sends a CLF message indicating that intra-office user has hung up.
    - If peer user first hangs up, peer device sends a CBK message indicating that peer user has hung up. Then intra-office user hangs up and sends a CLF message.
  9. Peer device sends an RLG message indicating that peer device is informed that intra-office user has hung up.
- [Figure 4-8](#) shows the call failure signaling process.

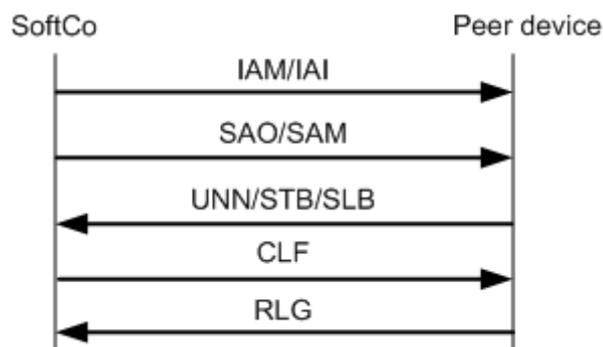
**Figure 4-8** TUP call failure signaling process

When intra-office user fails to call peer user, peer device sends a message according to the user status.

- If peer user number does not exist, peer device sends a UNN message to SoftCo device.
- If peer user is busy, peer device sends an STB message or an SLB message to SoftCo device.

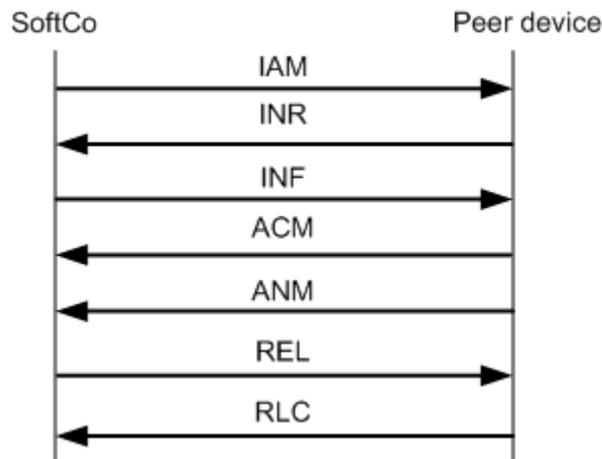
**Figure 4-9** Normal ISUP signaling process

- [Figure 4-9](#) shows the normal ISUP signaling process.

The normal ISUP signaling process is as follows:

1. When intra-office user calls peer user, intra-office users sends an IAM message containing the information about peer user address.
  2. Peer device returns an INR message containing other information required for establishing the call.

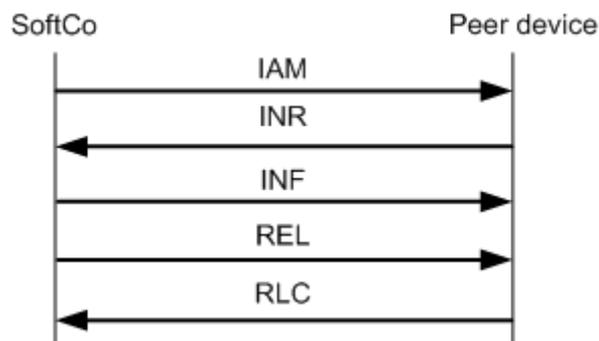
**Figure 4-10** ISUP call failure signaling process

8. peer device device sends an RLC message indicating that peer device is informed that intra-office user has hung up.
- [Figure 4-10](#) shows the call failure signaling process.

When intra-office user fails to call peer user, peer device sends an REL message. The REL message contains call failure causes.

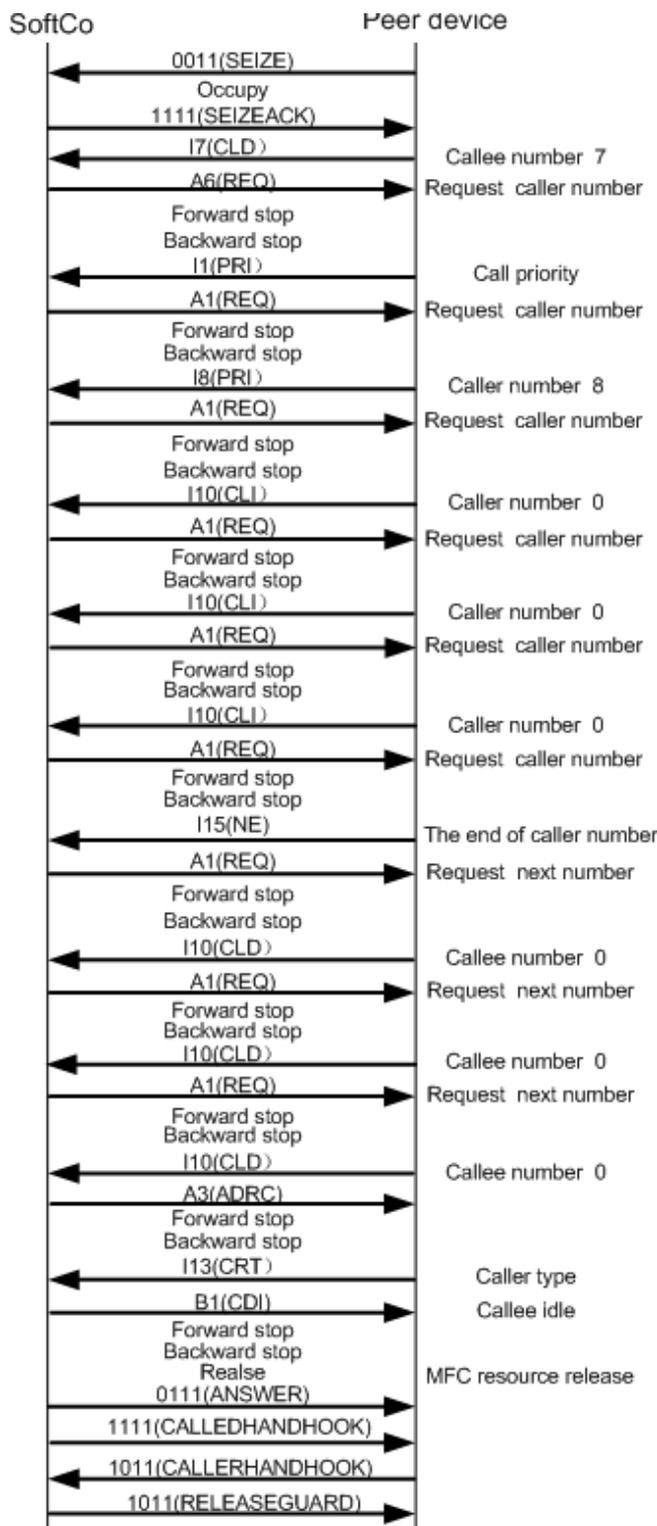
**Figure 4-11** Normal signaling process

An peer user (number 8000) calls an intra-office user (number 7000). [Figure 4-11](#) shows the normal signaling process.

The following describes the signaling process:

1. An peer user calls an intra-office user. peer device sends a seizing signal.
2. SoftCo returns a seizing-acknowledgement signal.

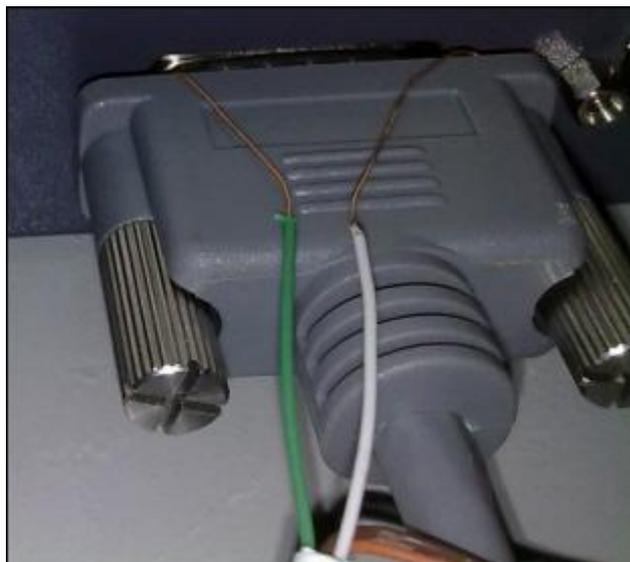
**Figure 4-19** Grounding connection

[Figure 4-19](#) indicate the SoftCo uses the PGND cables to connect the analog user cable to the grounding terminal.

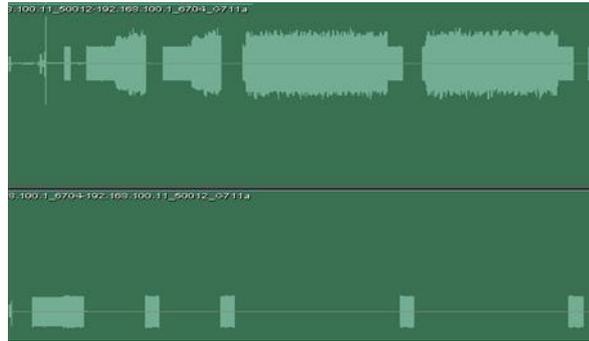
**Figure 5-12** Waves for fax signals in normal cases

- [Figure 5-12](#) compares waves for signals received and sent when an IAD user can send and receive faxes successfully. The average Root Mean Square (RMS) power is about -21 dB, as shown in [Figure 5-13](#).

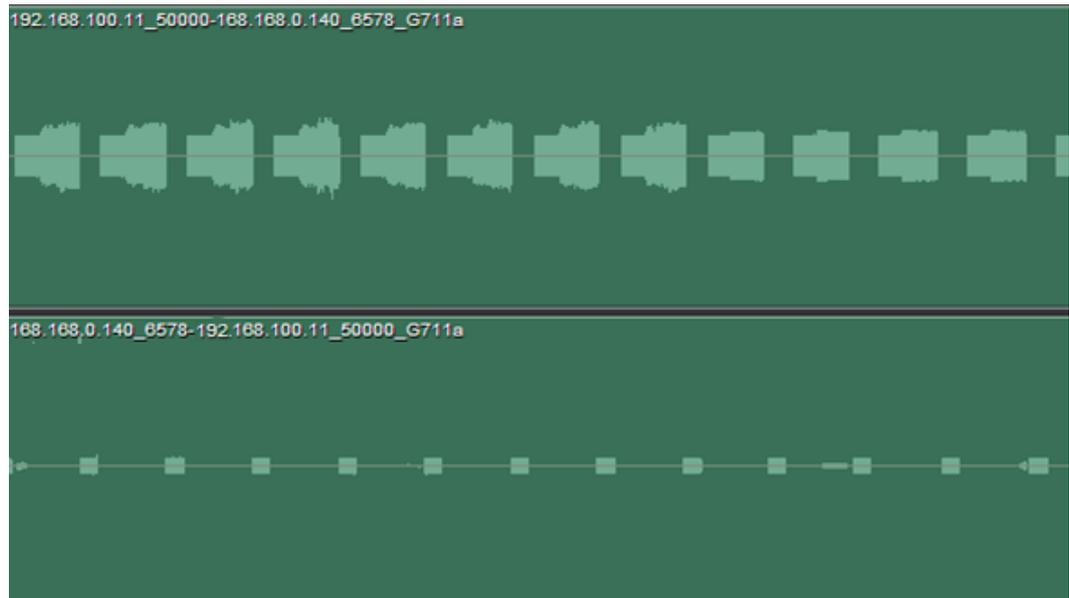
**Figure 5-14** Waves for signals of faxes that cannot be sent

- **Figure 5-14** compares waves for signals received and sent when an IAD user cannot send faxes.

In the chart, **192.168.100.11\_50000-168.168.0.140\_6578\_G711a** is the waves for signals that are sent, and **168.168.0.140\_6578-192.168.100.11\_50000\_G711a** is the waves for signals that are received.

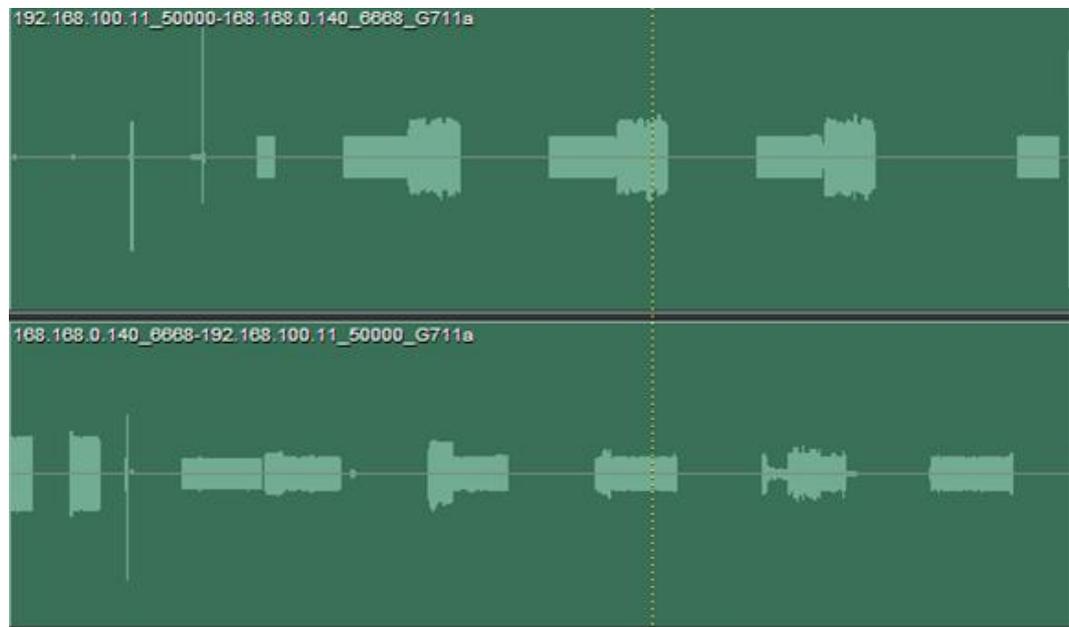
**Figure 5-15** Waves for signals of delayed faxes

- [Figure 5-15](#) compares waves for signals received and sent when faxes are delayed. This fault is caused by incorrect trunk line connection. If this fault occurs, contact the peer device engineers to check the line.

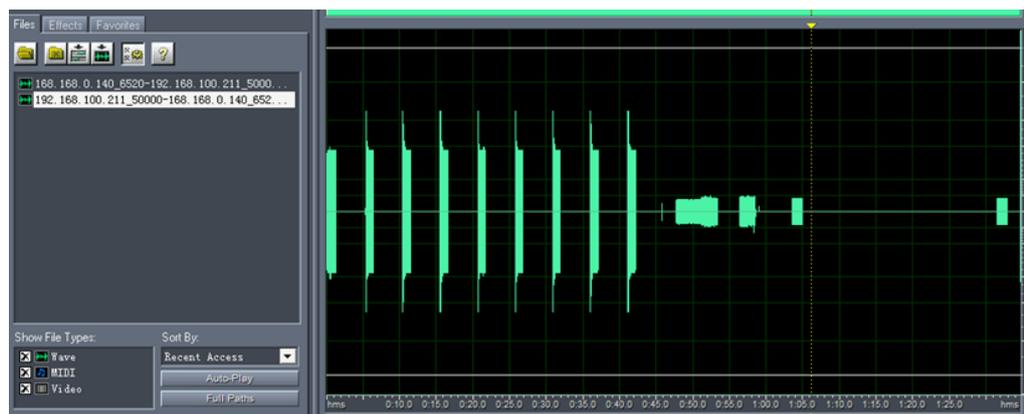
**Figure 8-1** Wave spectrum

**Step 2** In the main menu, choose **File** > **Open**. The **open** dialog is displayed. Then choose **.wav** file. the waveform is displayed in the main interface, as shown in [Figure 8-1](#).

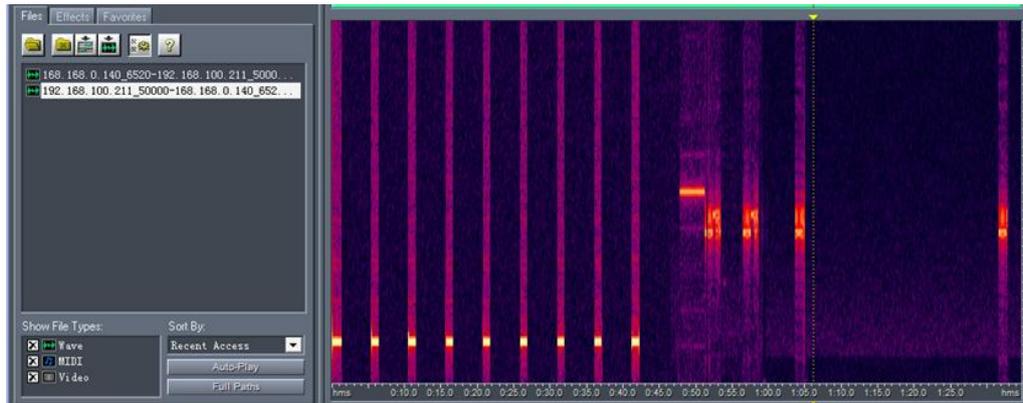
**Figure 8-2** Frequency spectrum

, the frequency spectrum is displayed, as shown in [Figure 8-2](#).

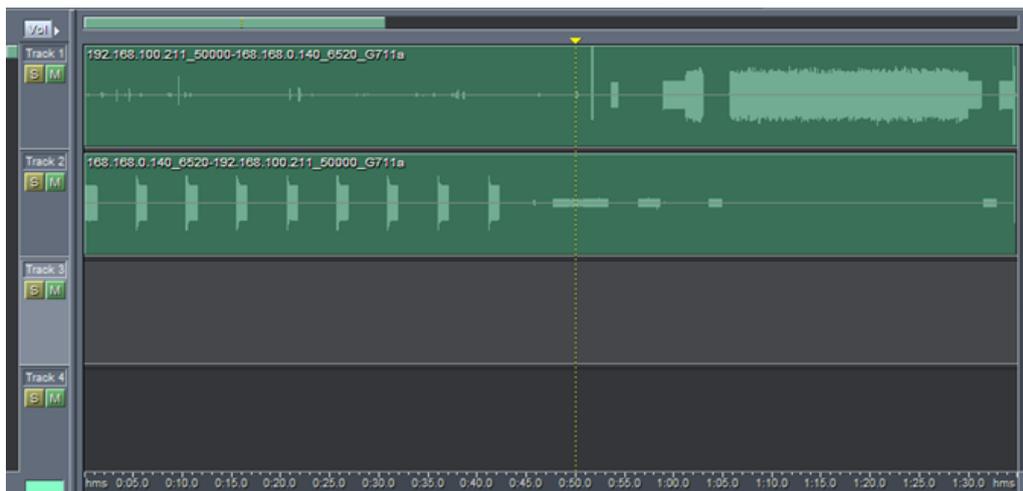
**Figure 8-3** Contrasted signal spectrum

to contrasting send and receive signal, as shown in [Figure 8-3](#).

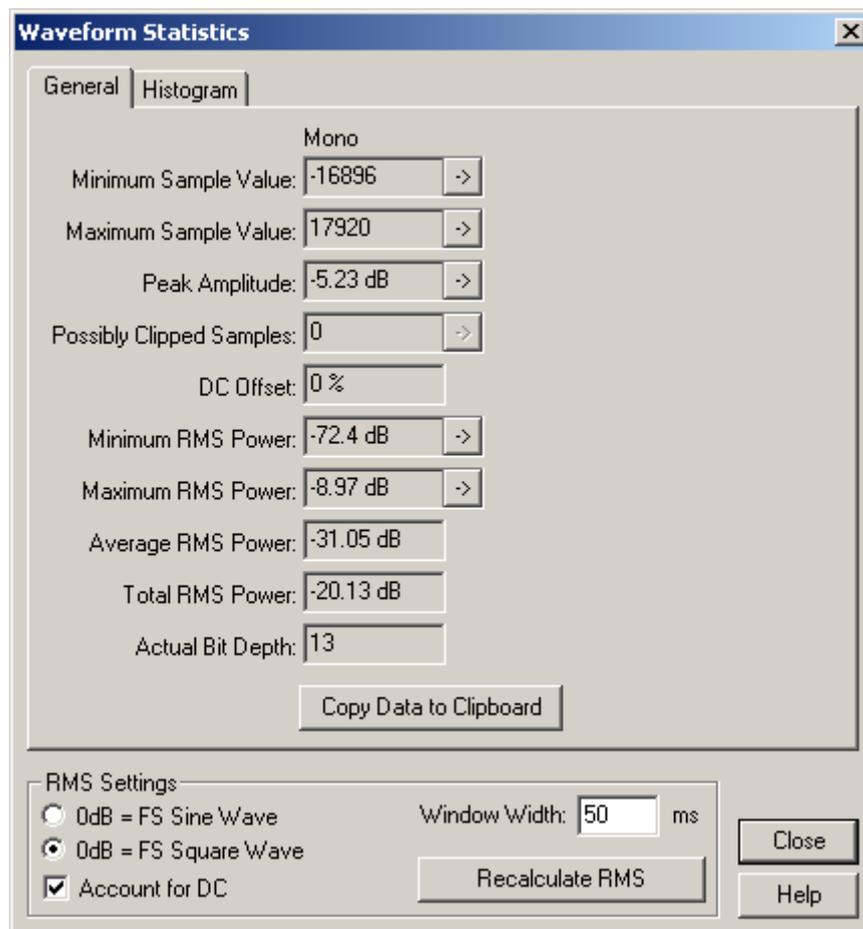
**Figure 8-4** Waveform statistics

**Step 5** In the main menu, choose **Analyze > Statistics**, the **Waveform statistics** is displayed, as shown in [Figure 8-4](#).
