# **Quidway S6700 Series Ethernet Switches**

## **V100R006C00**

# **Troubleshooting**

This document describes the procedure for troubleshooting various services supported by the S6700 in terms of common causes, flowchart, troubleshooting procedure, alarms and logs, and case studies.

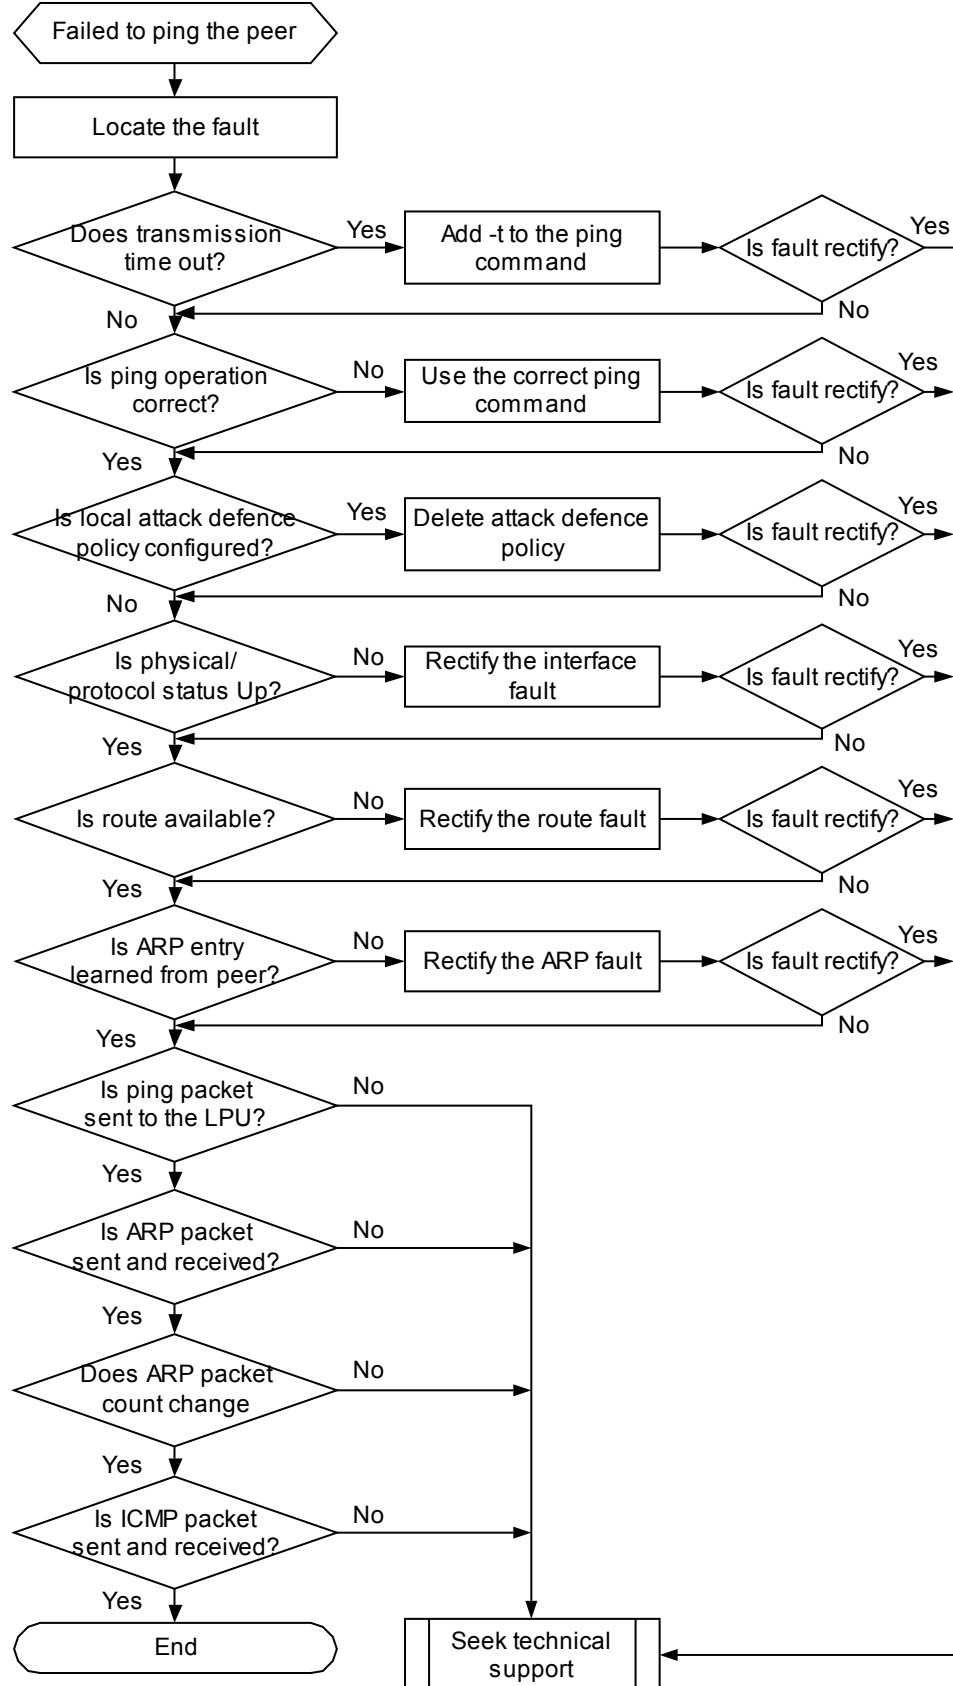
**Figure 6-3** Troubleshooting flowchart

- Check the routes between two ends.
- Check whether the device has learned the ARP entry of the peer.
- Check whether ICMP packets are discarded.
- Check whether the physical links or interfaces function properly.
